PERFORMANCE OF SOME CANAL AND DUGOUT LININGS ON THE CANADIAN PRAIRIES *

K. Pohjakas

Canada Department of Agriculture,
Research Station
Swift Current, Saskatchewan

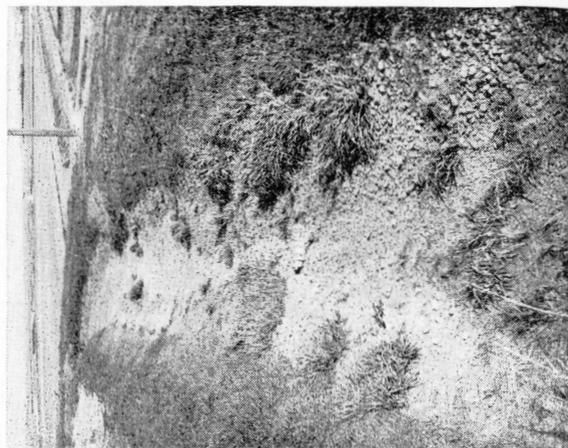
Figure 1. Catalytically blown asphalt on coarse aggregate after 14 years.

The other linings listed in table II were still in use. Seepage rates have increased with time but were still not excessive. Soil cover on the catalytically blown asphalt modified extremes in surface temperature and, when more than 6 inches thick, reduced the activity of asphalt - destroying bacteria (3). Asphalt blown on coarse aggregate has proved to be effective. This lining was relatively thick and the surface was well protected by the coarse aggregate. Surface asphalt had disappeared from its upper side but the aggregate was still attached to the lining (figure 1).

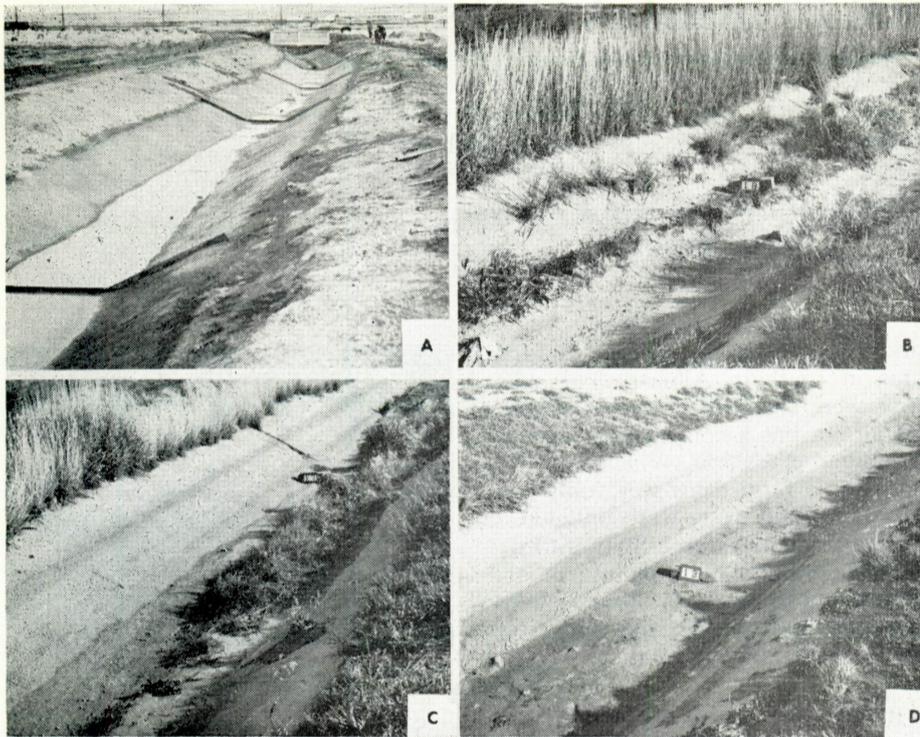
Figure 2. A—Shotcrete lining completed in 1950. Unreinforced 1/2-inch shotcrete lining after 15 years. B—Unreinforced 1/2-inch shotcrete lining after 15 years. C—Reinforced 1/4-inch shotcrete lining after 15 years. D—Reinforced 2-inch shotcrete lining after 15 years.

Results of tests with concrete linings (table III) were all obtained from the "A" lateral at the Swift Current Experimental Station. The linings had been installed in 1950 to test the effectiveness of pneumatically applied concrete of different thicknesses, and the effects of reinforcing and air entrainment on the durability of concrete linings (figure 2a). Most of the concrete lined section of the "A" lateral was in a cut, and seepage losses previous to lining were not very great. A lining placed in a canal passing through a cut is subject to more frost heaving because of the difficulty of draining the canal before freeze-up. A 1½-inch thick unreinforced section contained numerous, thick transverse and longitudinal cracks from which weeds grew (figure 2b). Its effect on seepage control was limited.

A 1¼-inch thick reinforced concrete lining contained intermittent longitudinal cracks about 1 foot from the bottom on both sides. There were a few hairline transverse cracks in this section (figure 2c). Seepage rates have increased since 1953 but the lining was still effective in 1965. A 3-inch thick unreinforced section contained ½- to 1-inch wide longitudinal cracks in the middle of both sides. Some top sections of lining had broken off and showed evidence of frost heaving. There were numerous ⅛-inch wide transverse cracks throughout the section but the lining was still controlling seepage. The most effective lining was a 2-inch thick reinforced section (figure 2d). On the south bank small pieces of lining were broken off apparently by cattle but the rest of the lining was in good condition and showed no evidence of cracks or weed growth. Ponding tests showed that the seepage loss was the lowest in this section.

In summary, the presence or absence of reinforcing steel was more important than the thickness of concrete. Air entrainment also appeared to have little influence on the durability of concrete. The reinforced 1¼-inch thick section was in much better condition than the unreinforced 3-inch section which cost almost twice as much as the thinner

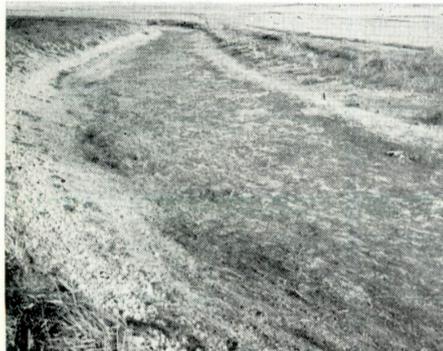
Figure 3. Swift Current main irrigation canal 2 years after 6 mil plastic was installed and covered with 12 inches of sand and gravel.

Black polyethylene plastic linings were first installed at Swift Current projects in 1955 to reduce seepage in areas where water losses were excessive; in some cases they replaced compacted earth linings. Earlier installations used 8-mil plastic but more recently 6-mil plastic has been used. Plastic linings used were the required width for all small- and medium-size canals so that only one transverse field joint was needed for each folded section of the lining ranging in length from 100 to 200 feet. The standard installation practice allowed 1 foot of freeboard above the full supply level (FSL) and another 1 to 1½ feet of the lining was required on both banks for anchoring. This was accomplished by excavating a narrow ditch about 1 foot above the FSL, and burying the outside edges of the plastic sheet in the ditch bank to prevent the plastic from sliding down the slope. Ditch banks were previously graded to a slope not exceeding 3 to 1, all sharp objects were removed by raking, and the finished surface was rolled smooth. The linings were covered either with the material excavated from the ditch or with sand and gravel hauled to the site. The exposed gravel surface provided better erosion control, but was more costly because of the transportation expense (figure 3).
