Isolating the effect of material properties in the wear of soil engaging tools

**Written for presentation at the
CSBE/SCGAB 2009 Annual Conference
Rodd's Brudenell River Resort, Prince Edward Island
12-15 July 2009**

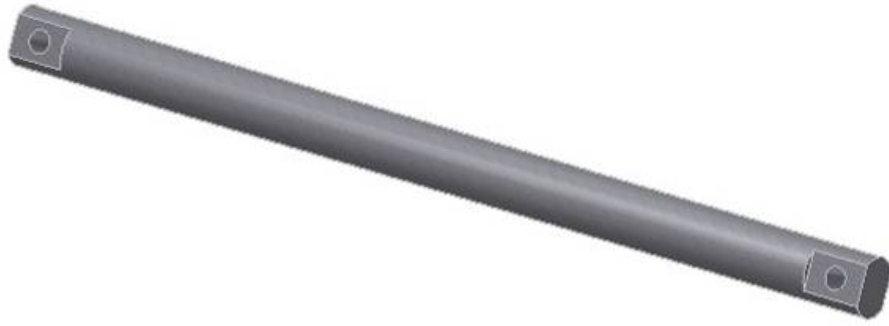
Figure 1. Test specimen geometry

As a compromise between simplicity for future modeling and ease of use in the soil bin, a cylindrical rod pulled horizontally was chosen as the tool shape (Fig. 1). The rounded profile allowed soil to move freely past the tool and there was no effect of a corner or sharp edge that would wear differently over time. As the leading profile remained relatively consistent, little change in soil pressure would be present.

Length of the bar was chosen to be approximately half the available width of the soil bin, 400 mm. To determine an appropriate diameter, calculations were completed to find the minimum diameter that would limit the amount of flexure. According to draft data recorded by Hunt (1983) for a rodweeder and the flexure formula,

a diameter of 25 mm was found to provide less than 1 mm of deflection in the center of the bar for steel and was considered sufficient for the experiment.

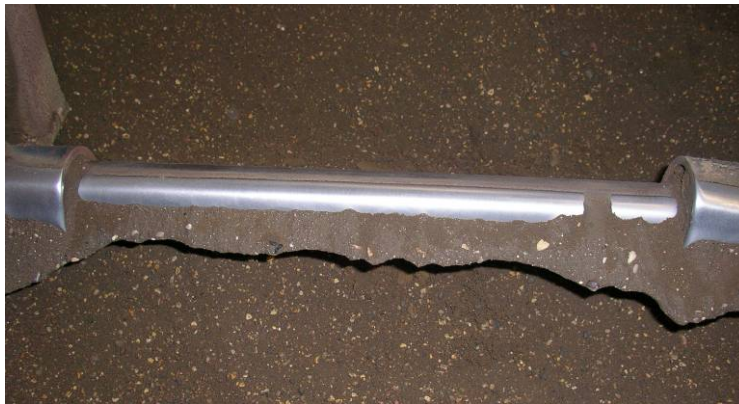
Figure 4. Soil formation after completion of a run.

Each of the six bars exhibited visible wear following 400 km of travel. Visual inspection showed that wear was concentrated at two particular locations around the circumference of the bar (Fig. 9). Along the leading edge (defined as 0 degrees), the bar was still in its original state and completely unaffected by wear. This phenomenon could be confirmed from the state of the bar in the soil just prior to removal from the soil bin (Fig. 4). The leading edge of the bar was covered with a layer of soil, thereby protecting the bar from abrasion.

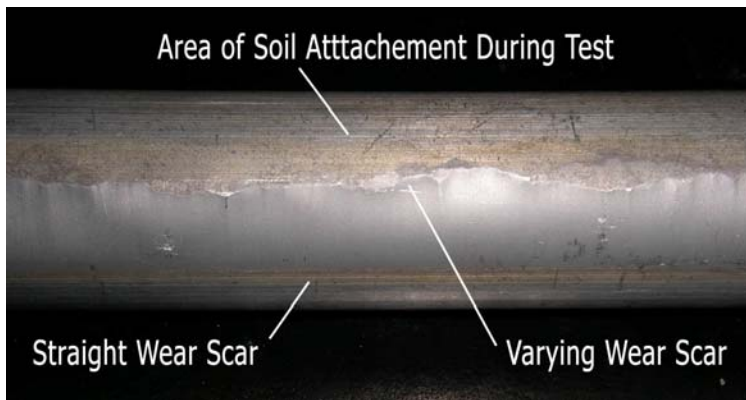
Figure 5. Variance in soil attachment creates an uneven wear edge as seen from the bottom of the specimen (90 degrees).

This is also the cause of the difference between the straight wear scar edge at the back side of the bar and the jagged surface at the leading edge of the scar (Fig 5). Because the soil stuck to slightly different areas on the bar with each run, the shape of the wear scar changed (Fig. 6) and layers of wear could be seen.

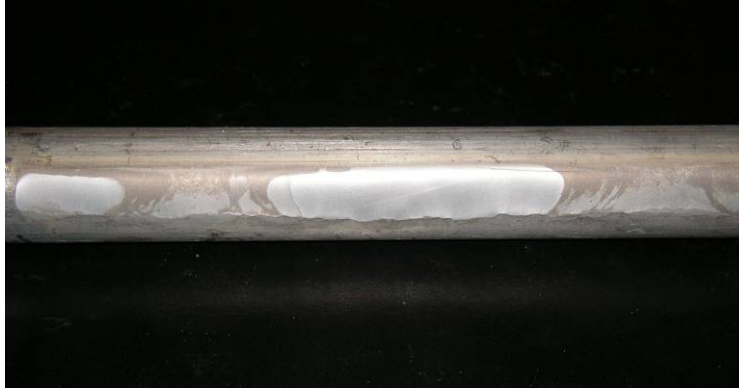
Figure 6. Wear scar layering caused by differences in soil attachment over a set of runs.

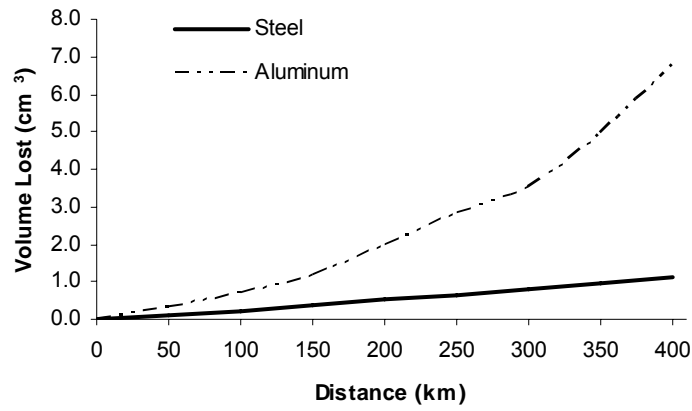
Figure 8. Average volume lost calculated from mass change

Mass data were collected at each 50-km interval. Volume loss was then determined using the material density. Although mass data were very similar initially, with approximately 1 g of material removed at each interval, the difference in densities proves obvious when volume loss is considered (Fig. 8). The general history of mass loss was exponential for the aluminum as the rate of wear increased with each measurement. For the steel, the rate of volume loss remained quite consistent which may be a result of the low wear rate. It could be assumed that the exponential type wear would also occur in the future but over the interval of study, this level of wear was not yet reached. Over the entire exposed area of the bar, the aluminum lost approximately 6.8 cm^3 while only about 1.1 cm^3 was removed from the steel after 400 km of travel.

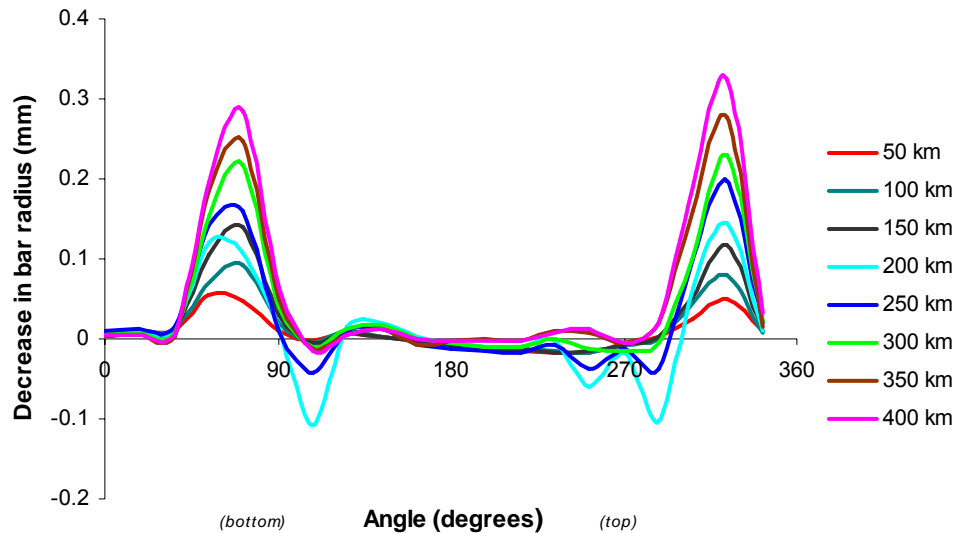
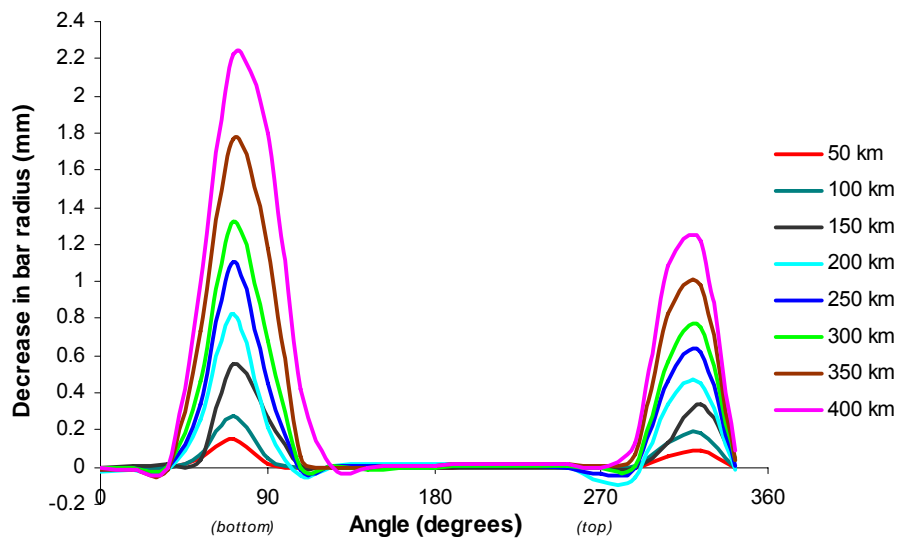
Figure 10. Radius change as a function of angle of measurement for (a) steel and (b) aluminum

When plotted as a function of the measurement angle, Fig. 10 illustrates that wear was concentrated at about the 72 and 324 degree marks. While most of the bar did not wear, the wear measurement came to a distinct maximum which indicates that material was not removed evenly from the entire surface. Instead, as is seen in Fig. 9, it is a segment of the profile which is worn. With regard to the aluminum, the area at 72 degrees experienced more wear as it was located on the lower edge of the profile where higher soil pressures would exist. Soil could easily flow above the bar but at the lower edge compaction was required to allow the bar to pass through the soil. This extra pressure increased the abrasive wear which occurred.

As expected, the aluminum bars had the greatest reduction in radius. At the point of maximum wear, the radius of the aluminum bar was reduced by about 2.2 mm while the steel bars lost less than 0.35 mm. When comparing the two materials, both exhibited similar characteristics. The locations experiencing large amounts of wear were very similar but the aluminum showed much greater wear at the bottom location while the steel had similar radius change at the bottom and top wear locations.

One anomaly which is particularly obvious on the steel bar plot for the 200-km and 250-km measurement is the negative radius decrease. Physically this indicates that the bar grew in size which is not possible. As illustrated in Fig. 7, this may be due to the rust formation at the edge of the wear scar. As moist soil collected in this area it built up a very hard ridge which may have resulted in the CMM reading that the bar had an increase in radius. It is also possible that erroneous measurements were taken at these two intervals
